SERVICE *No. 173*
BULLETIN

Piper Aircraft Corporation
F. A. A. Approved

June 23, 1959

SUBJECT: Aileron Balance Weight Attachment Bulkhead

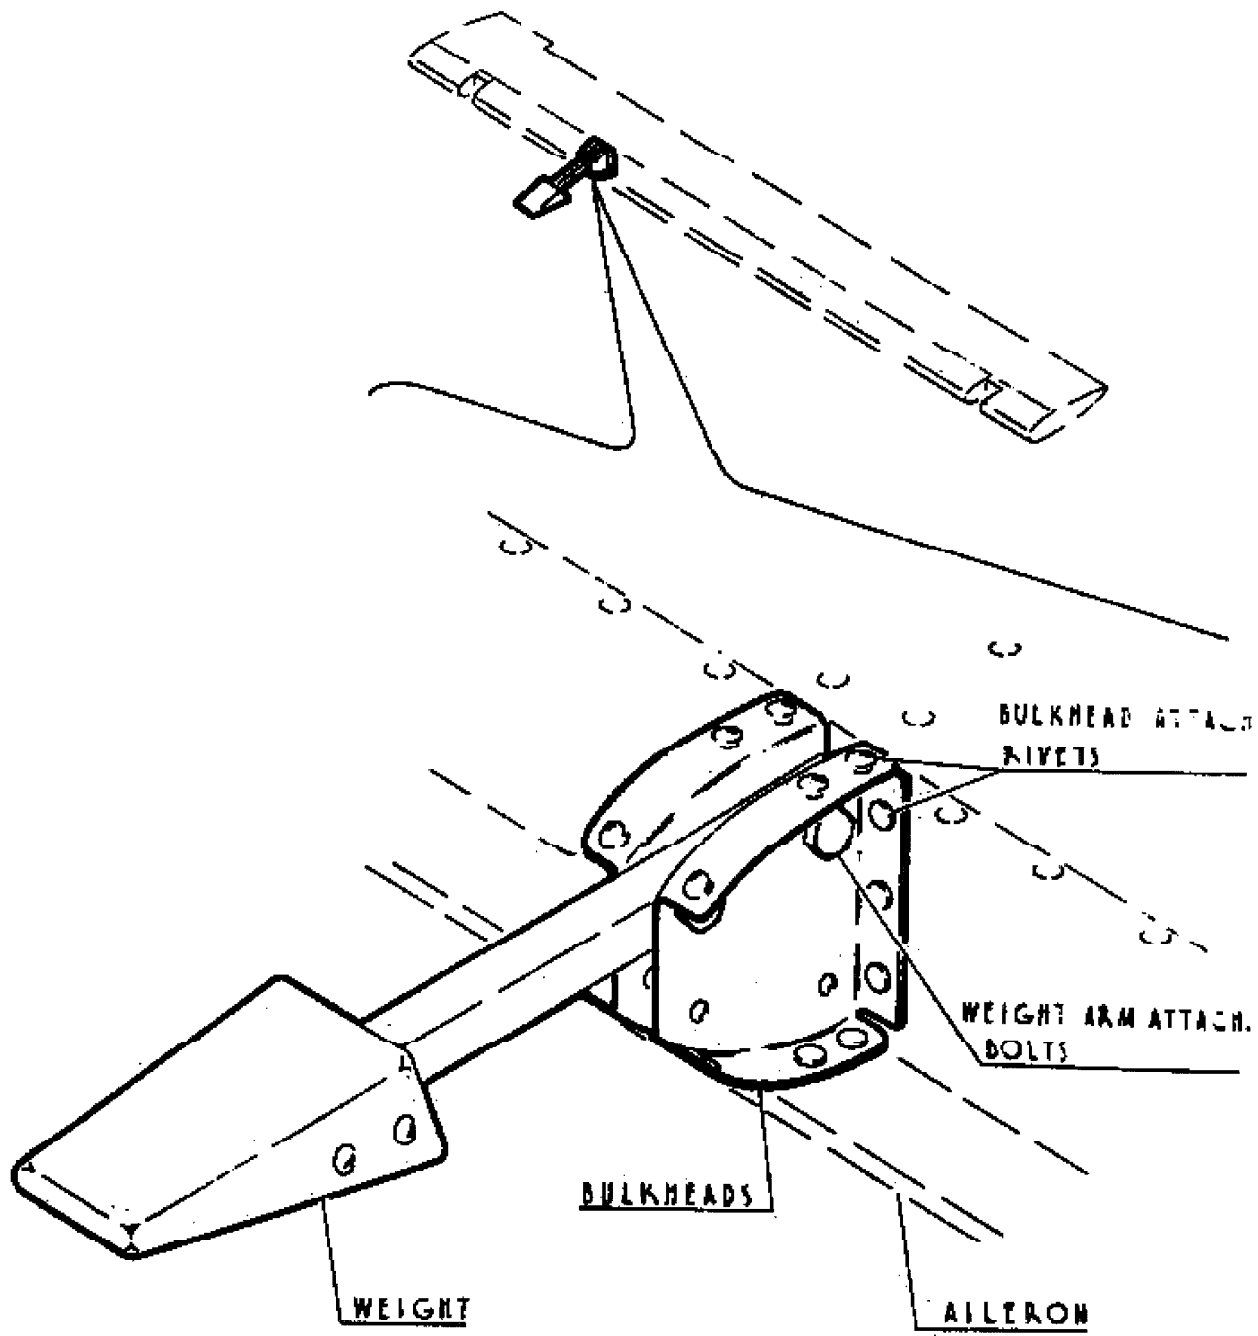
Several reports have been received by the Service Department that cracks have developed in the aileron balance weight attachment bulkheads. These bulkheads are riveted to the front spar of the aileron and are the support to which the balance weight arm is attached. See sketch below this bulletin.

This bulkhead, which has been re-designed to strengthen the area in which cracks have developed in the past, is now being used on current production airplanes.

At the next 100 hour inspection the two bulkheads on both ailerons must be replaced. Service kit, part number 754 233, is available from your nearest Piper distributor or dealer free of charge if the airplane serial number is included on the purchase order.

NOTE: Replace aileron balance weight attachment bulkheads on right aileron only on serial number 24-980.
