SERVICE BULLETIN

No. 210

Piper Aircraft Corporation

SUBJECT: Replacement or Modification of Muffler Shrouds

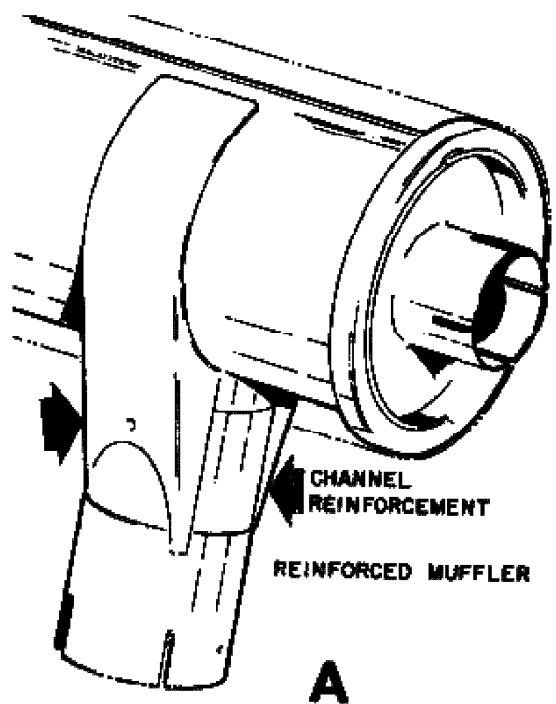
A

Comanche mufflers have been manufactured incorporating two different styles of tailpipe reinforcement brackets. However, this Service Bulletin requires modification of one style only; those with the channel-shaped reinforcement. See Sketch "A" for further identification. Both styles of muffler have been sold as service replacements. It will therefore be necessary to inspect aircraft, Serial Nos. 24-1 to 24-2587 inclusive if the original muffler has been replaced, to determine if compliance with this Bulletin is required.

CHANNEL
REINFORCEMENT

REINFORCED MUFFLER

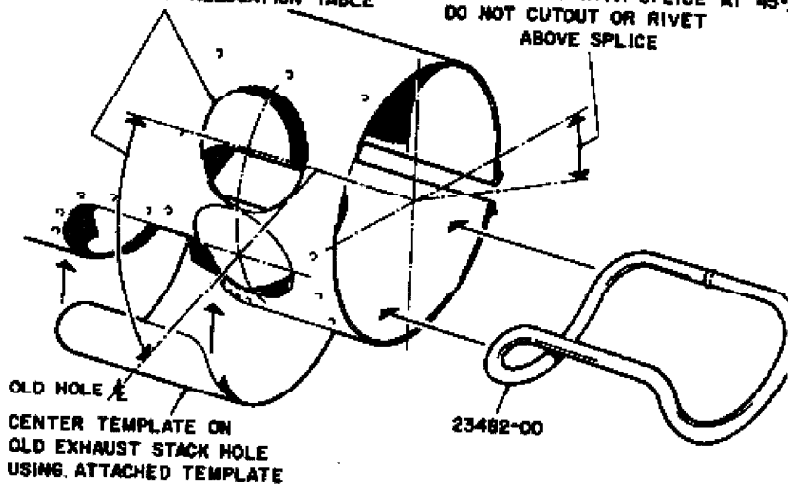
B

Service reports have been received advising of cracks located in the muffler housing near the tailpipe reinforcement strap. The muffler heater shroud has therefore been redesigned to remove the affected area from the heater system. This has been accomplished by increasing the shroud opening around the tailpipe, making the area more accessible for inspection.

8. Cut the new opening in the aluminum shroud, taking care not to cut past the splice. (See Note Sketch "B.")
 9. Install the muffler housing reinforcement tube, part number 23482-00, on the inside of the aluminum heater shroud. (See Sketch "B.")

10. Relocate the cold air inlet take-off assembly as shown on the take-off relocation table and install cover plate, part number 23498-00, over old hole. Trim cover plate as required. (See Sketch "B.")

RELOCATED 2" DIA. TAKE-OFF HOLE
SEE TAKE-OFF RELOCATION TABLE

ON SHROUDS WITH SPLICE AT 45°
DO NOT CUTOUT OR RIVET
ABOVE SPLICE

OLD HOLE
CENTER TEMPLATE ON
OLD EXHAUST STACK HOLE
USING ATTACHED TEMPLATE

COVER PLATE 23498-00 TAKE-OFF ASSEMBLY

CUTOUT APPROX. $\frac{1}{8}$ " FROM INSIDE
OF REINF. TUBE
