SERVICE BULLETIN NO. 222A - PIPER

SUBJECT: Removal of Restriction to Air Speed Limits (Replacement of Stabilator Torque Tube)
MODELS AFFECTED: PA-30 Twin Comanches. Serials 30-1 to 30-482 incl., 30-484 to 30-491 incl., 30-493, 30-494, 30-496 to 30-502 incl., 30-504, 30-505, 30-507 to 30-565 incl.
NOTE: Serial Numbers 30-483, 30-492, 30-495, 30-503 and 30-506 have been modified at the factory and require only removal of placard and temporary supplement to flight manual for compliance.
COMPLIANCE DATE: Prior to but not later than 10 hours of operation after receipt of stabilator torque tube.

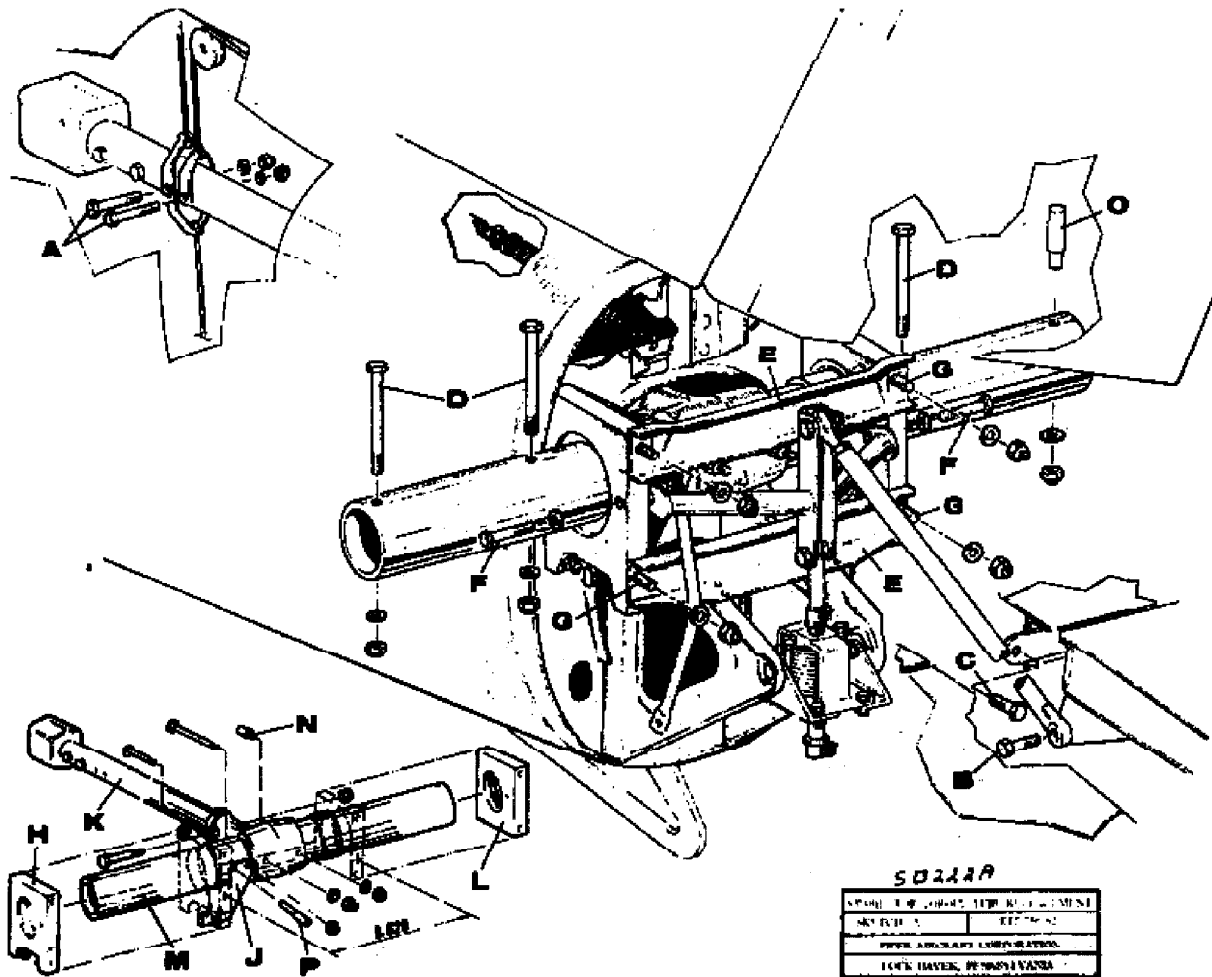
Owners and operators of the subject aircraft were advised recently that because vibration at approximately the red line not-to-exceed limit had been observed, it was necessary to restrict the air speed.

It has been determined that a stabilator torque tube, part number 22655-07, of heavier wall thickness will eliminate this vibration.

1. Remove fuselage access cover plate.

2. Disconnect stabilator control cables on balance weight arm. Item A.
3. Remove bolt from stabilator trim tab born. Item B.
4. Remove bolt from stabilator rear spar. Item C.

5. Remove four bolts attaching stabilator to stabilator torque tube and remove stabilators. Item D.
6. Remove top and bottom fuselage tail fairings.
7. Remove stabilator bearing block reinforcement channels. Item E.

8. Remove two bolts holding stabilator tab control bellcrank assembly to stabilator bearing blocks. (It is not necessary to further disassemble this unit) Item F

9. Remove the bolts from the right stabilator bearing block and the bottom bolt in the left bearing block. DO NOT REMOVE the top bolt in the left bearing block. Item G.
(Caution - Mark top for proper reassembly.)

10. By pulling rearward and rotating the right end of the stabilator torque tube downward to pass the rudder arm, the entire torque tube and counterbalance assembly can be removed from the aircraft. The top left bearing block bolt should stay in place .

11. During disassembly of the torque tube assembly note the position of parts so that it can be properly reassembled.
12. Remove left bearing block by tapping with a soft mallet. Note shims, part number 81262-72 if installed. Item H.

13. Remove stop assembly. Item J.
14. Remove counterbalance arm assembly. Item K.
15. Remove right bearing block assembly. Note shims (81262-72) if installed. Item L.

16. Install counterbalance arm assembly on new stabilator torque tube, part number 22655-07. Note position in View B. Item M.

Holes drilled in the torque tube assembly are undersize and will be line-reamed on assembly. Since the holes in counterbalance arm assembly and stabilizer fittings have already been reamed, a special locating pin, part number 25304-00 is included with each torque tube to insure proper fit of these assemblies. Item N.

When counterbalance arm is position, insert locating pin, part number 25304-00 in one hole until the shoulder bottoms on the torque tube.

Ream the other hole in the tube to .3120 to .3130. Insert bolt in reamed hole before removing locating pin to ream the second hole.

17. Install stop assembly referring to Item J.

Holes drilled in the torque tube assembly are undersize and will be line reamed on assembly. Since the holes in stop assembly have already been reamed, a special locating pin, part no. 25304-02, is included with each torque tube to insure proper fit of these assemblies. Item P.

When stop is in position, insert locating pin, part no. 25304-02, in one hole until the should bottoms on the torque tube.

Ream the other hole in the tube to .2465 to .2475. Insert bolt in reamed hole before removing locating pin to ream the second hole.

18. Install left bearing block, Item H, right bearing block, Item L.

Shims, part no. 81262-72, should be installed with bearing blocks in same position as when removed to maintain a dimension of 8.620 shown in View C.

19. Reinstall torque tube assembly on aircraft in reverse order of disassembly.
20. Install stabilators and bolt the rear spar. Insert locating pin in same manner as previously used in one hole on either stabilator. Ream the other hole to .3120 to .3130 and install bolt. Item O.

Remove locating pin and ream the second hole.

Repeat above process on the other stabilator.

21. Connect control cables and complete reassembly of fairings. Item A.
