SERVICE BULLETIN ^{No. 411A}

Piper Aircraft Corporation

Subject: Stabilator Torque Tube Bearing Block Attachment Fitting Rivet Replacement

Service Bulletin 411A

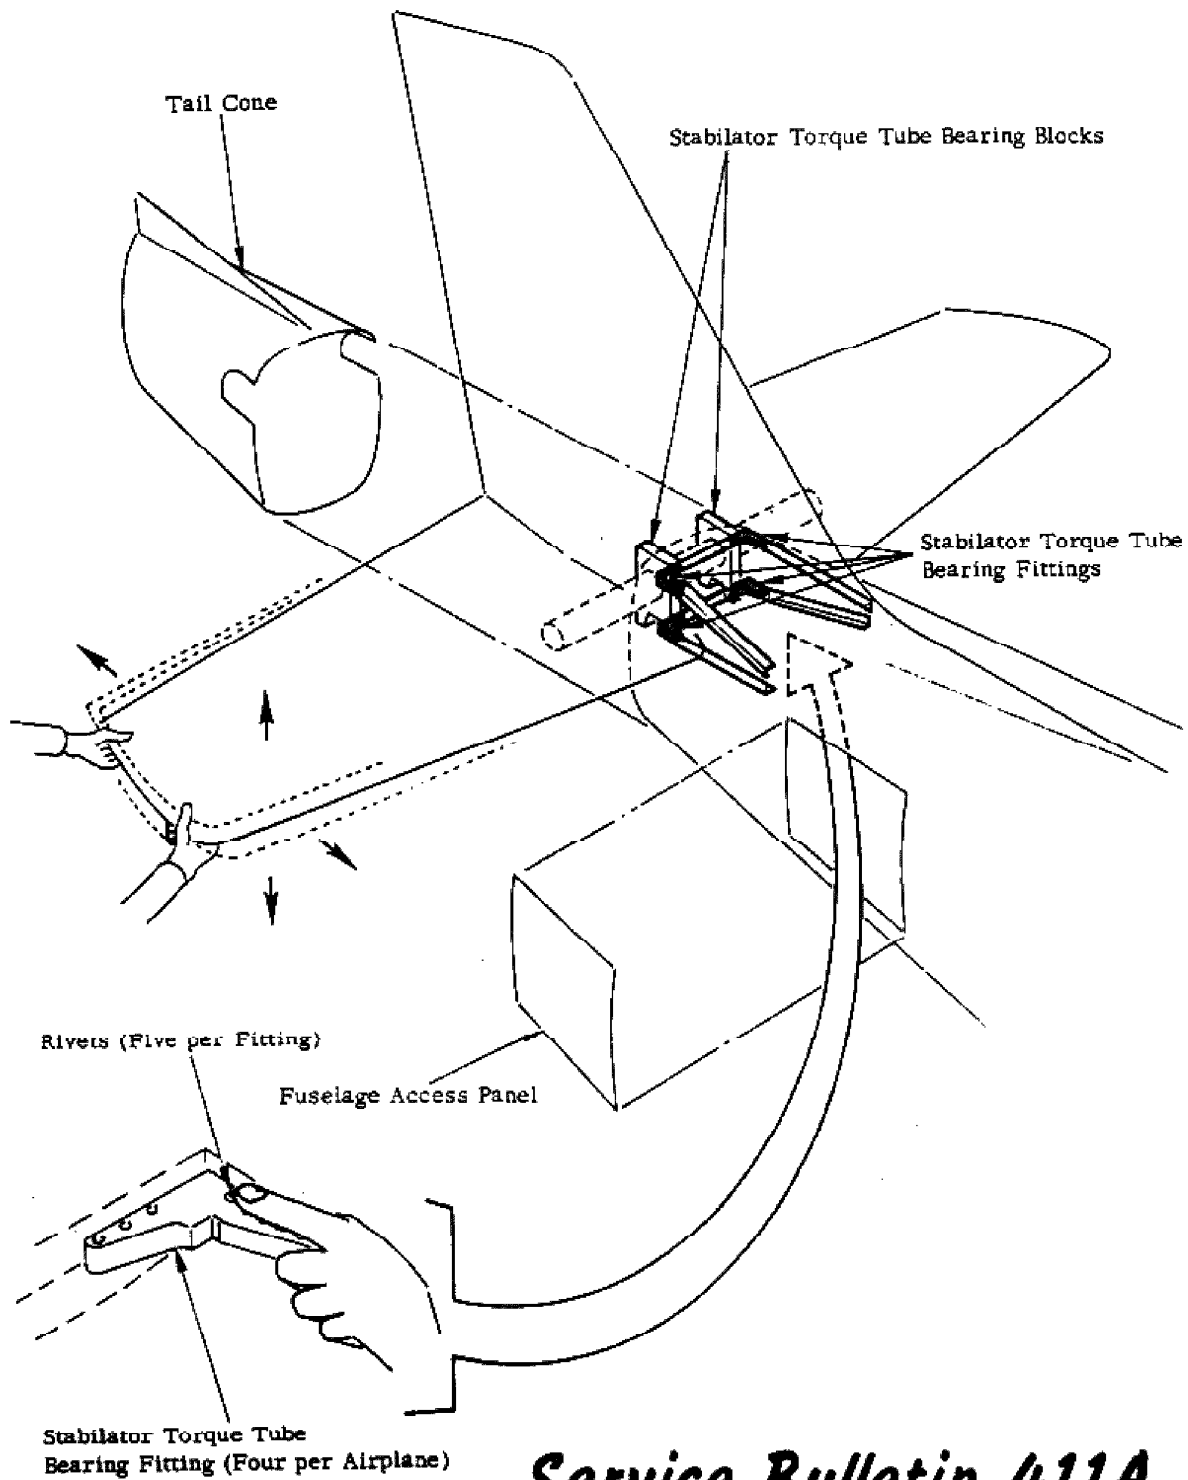
Purpose: Information has been received by the factory describing movement and/or noise in the area where the stabilator assembly joins the fuselage. It has been determined that the above described condition may have been caused by one of the following (refer to sketch for a pictorial description of the affected areas):

1. Stabilator torque tube bearings not firmly seated in the stabilator torque tube bearing blocks.
2. The holes in the stabilator torque tube bearing upper and lower fittings may be enlarged.

1. Grasp the stabilator tip and exert a fore and aft force and then an up and down force.
2. Simultaneously (with Step 1, above), have another person check closely for movement and/or noise in the area described in Purpose, above (the sketch illustrates a recommended method of detecting movement in the stabilator torque tube bearing fittings area).
3. If there are no indications of movement and/or noise, no further action is required (other than log book entry).
4. If there is movement and/or noise in the area described in Purpose, above, immediately contact the Customer Services Department, Piper Aircraft Corporation, Lock Haven, Pennsylvania 17745.
