SERVICE BULLETIN No. 751

Piper Aircraft Corporation

Subject: Spar Cap Chafing Inspection

PA-24-400 Comanche	26-2 and up
PA-24-180/250/260 Comanche	24-1 and up
PA-30 Twin Comanche	30-2 to 30-2000 Inclusive
PA-39 Twin Comanche C/R	39-1 to 39-155 Inclusive

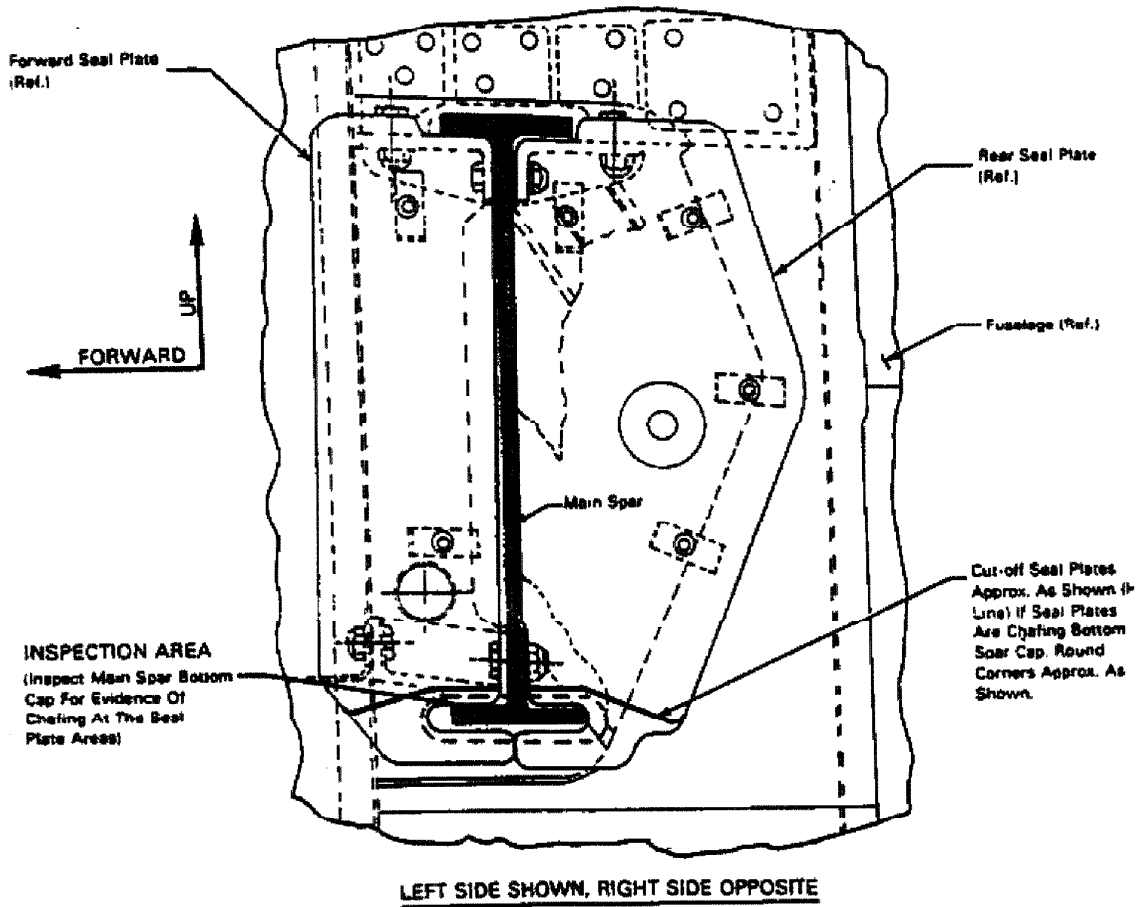
Several cases have been reported of chafing of the wing main spar lower cap where the spar enters the fuselage. This is caused either by deterioration of the rubber baffle material attached to the front and rear seal plates or by improper re-installation of the subject plates. Either situation may allow the seal plates to contact and chafe the lower spar cap.

1. Obtain access to the affected area of the lower spar cap by removing the lower wing root fairing.
2. With reference to the sketch, trim off the lower portion of each seal plate using a pair of aviation sheet metal shears.
