## 777 - Piper

June 16, 1976

Fin Front Spar Modification.

PA-30 Twin Comanche  
PA-39 Twin Comanche "C/R"

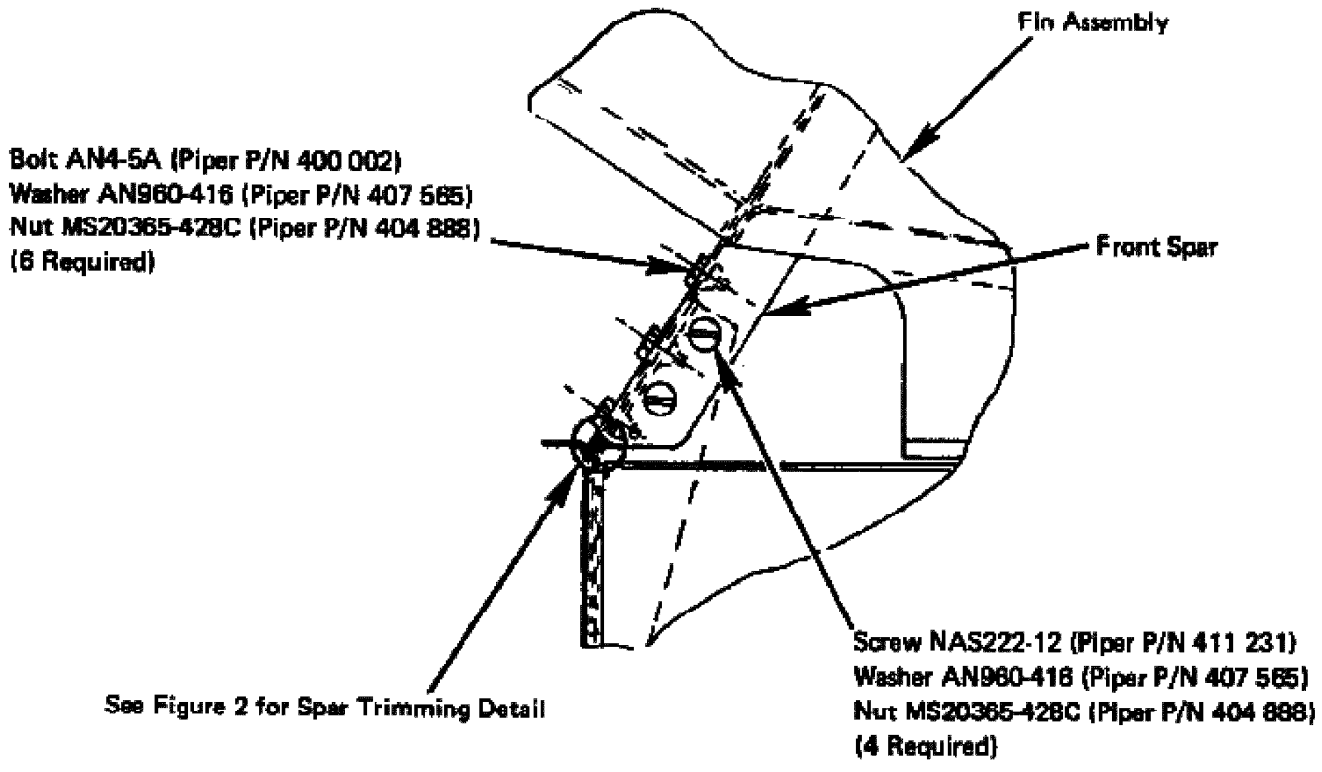
**FIGURE 1**

FAA Airworthiness Directives #75-12-06 dated June 5, 1976 required a repetitive inspection of the PA-24 Comanche series Fin Front Spar to Fuselage Attachment Channel bend relief holes for evidence of cracks; repair or replace cracked channels/ straps if cracks are detected . . . etc. We have been advised that, in the near future, the FAA is planning a similar action relative to the PA-30 and PA-39 Twin Comanche series.

Since it is necessary to physically remove the Fin Assembly to gain visual access to the channel relief holes (as the Fin Front Spar extends over the relief holes diameter), this service release provides instructions to modify the Fin Front Spar to eliminate repetitive removal of the fin and to enable an easy visual inspection.

**(FIN FRONT SPAR ATTACHMENT)**
