# SERVICE LETTER 679 - PIPER

**SUBJECT:**  
Fuselage Aft Bulkhead Inspection

**MODELS AFFECTED:**  
PA-30 Twin Comanche  
PA-39 Twin Comanche C/R

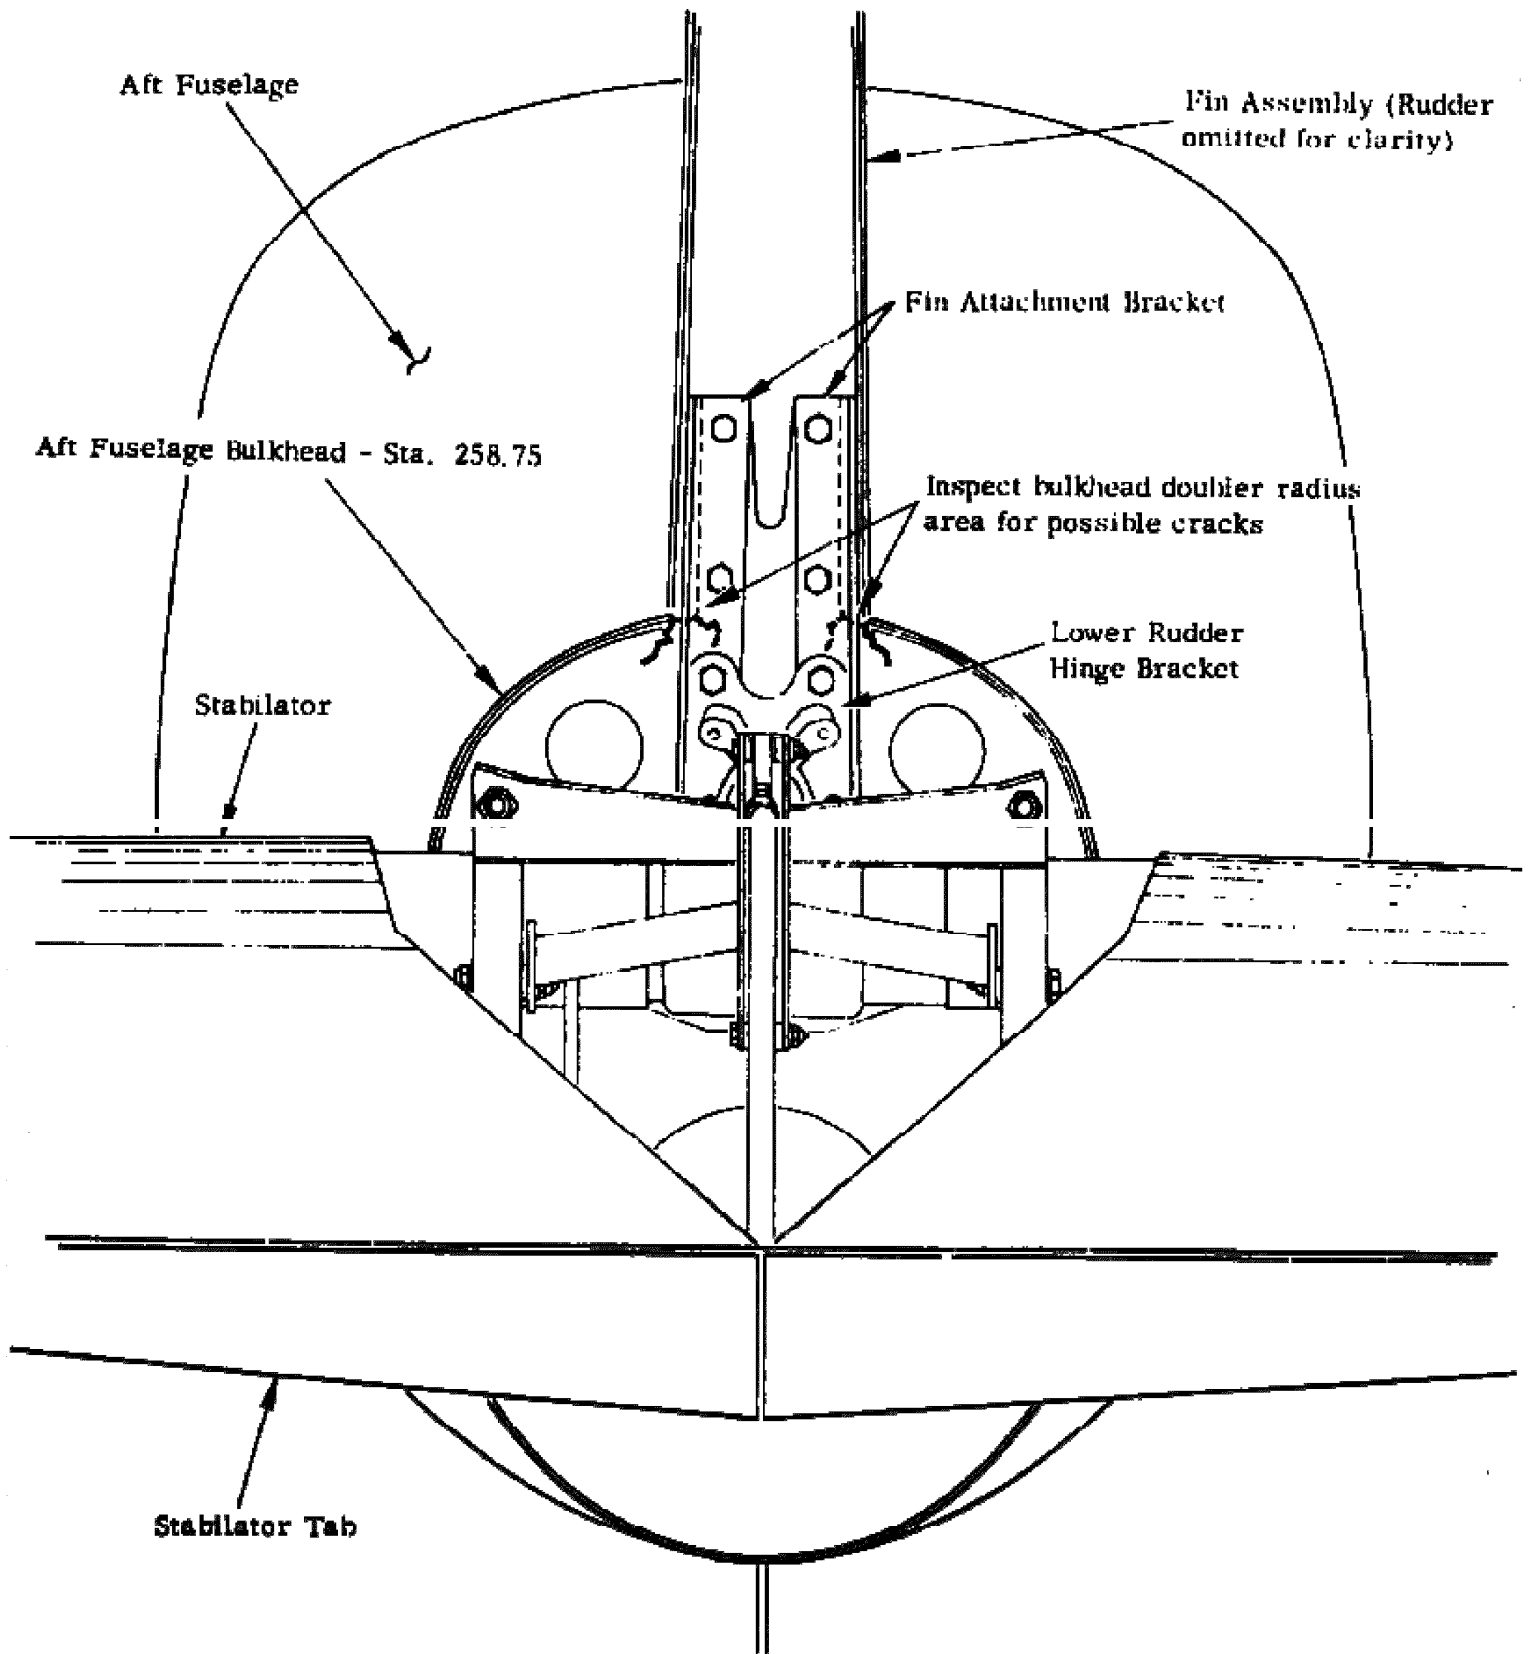
SKETCH

**PURPOSE:**  
To provide instructions to inspect the fuselage aft bulkhead doubler at fuselage station 258.75 in the area of the aft fin attachment brackets for evidence of cracks and to provide material and instructions to reinforce this area (1) if cracks are detected or (2) to alleviate the repetitive inspection requirements as stated in Compliance Time, above.

TYPICAL VIEW OF AFT FUSELAGE (LOOKING FORWARD)

1. Conduct inspection in accordance with the provisions of the sketch/instruction sheet.
2. If no cracks are detected in this area, no further action is required at this time (except continuing repetitive inspections until Kit 760 783 is installed); however, it is the owner's/operator's option whether to install the Fin Attachment Bracket Installation Kit, Piper Part No. 760 783, to relieve the inspection requirements referenced in Compliance Time, above.
3. If cracks are detected in this area, it will be necessary to install the Fin Attachment Bracket Installation Kit, Piper Part No. 760 783; installation instructions are contained in the kit.
4. Make appropriate log book entry.

- INSTRUCTIONS:**
1. Remove tail cone fairing assembly from aft fuselage.
  2. Carefully inspect bulkhead doubler on both sides of fin attachment brackets, as shown above, for evidence of cracks.
