SERVICE *No. 366*
LETTER

TO: Distributors, Dealers, Certified Service Centers and Owners
SUBJECT: Nose Gear Clevis
MODELS AFFECTED: PA-24 and PA-24 "250" Comanches - Serial Nos. 24-1 to 24-2609 inclusive

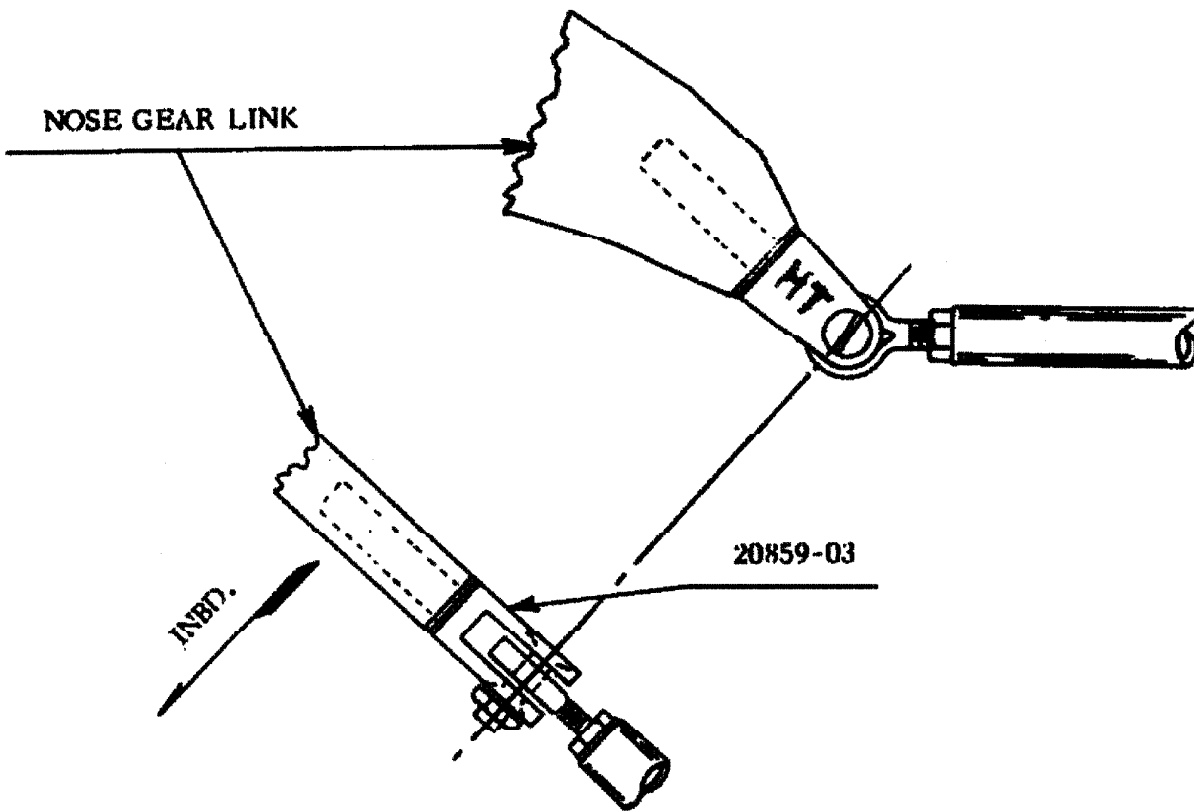
A new high strength nose gear clevis, part number 20859-03, is available to replace the nose gear clevis with which the early models of Comanche aircraft were equipped.

This new clevis may be identified by the letters "H.T." etched on the side of the fitting. We are of the opinion that since this new high strength fitting will provide longer service life, the owners and operators of the affected aircraft should replace the present clevis with this improved one. See sketch below

This clevis, when installed, must be tight in the forgoing (13 to 40 ft. lbs. torque) and nut must be inboard.
